Preliminary damage mapping following the 2016 Kumamoto Mw7.1 Earthquake using pre- and post-event PALSAR-2 images

BACKGROUND

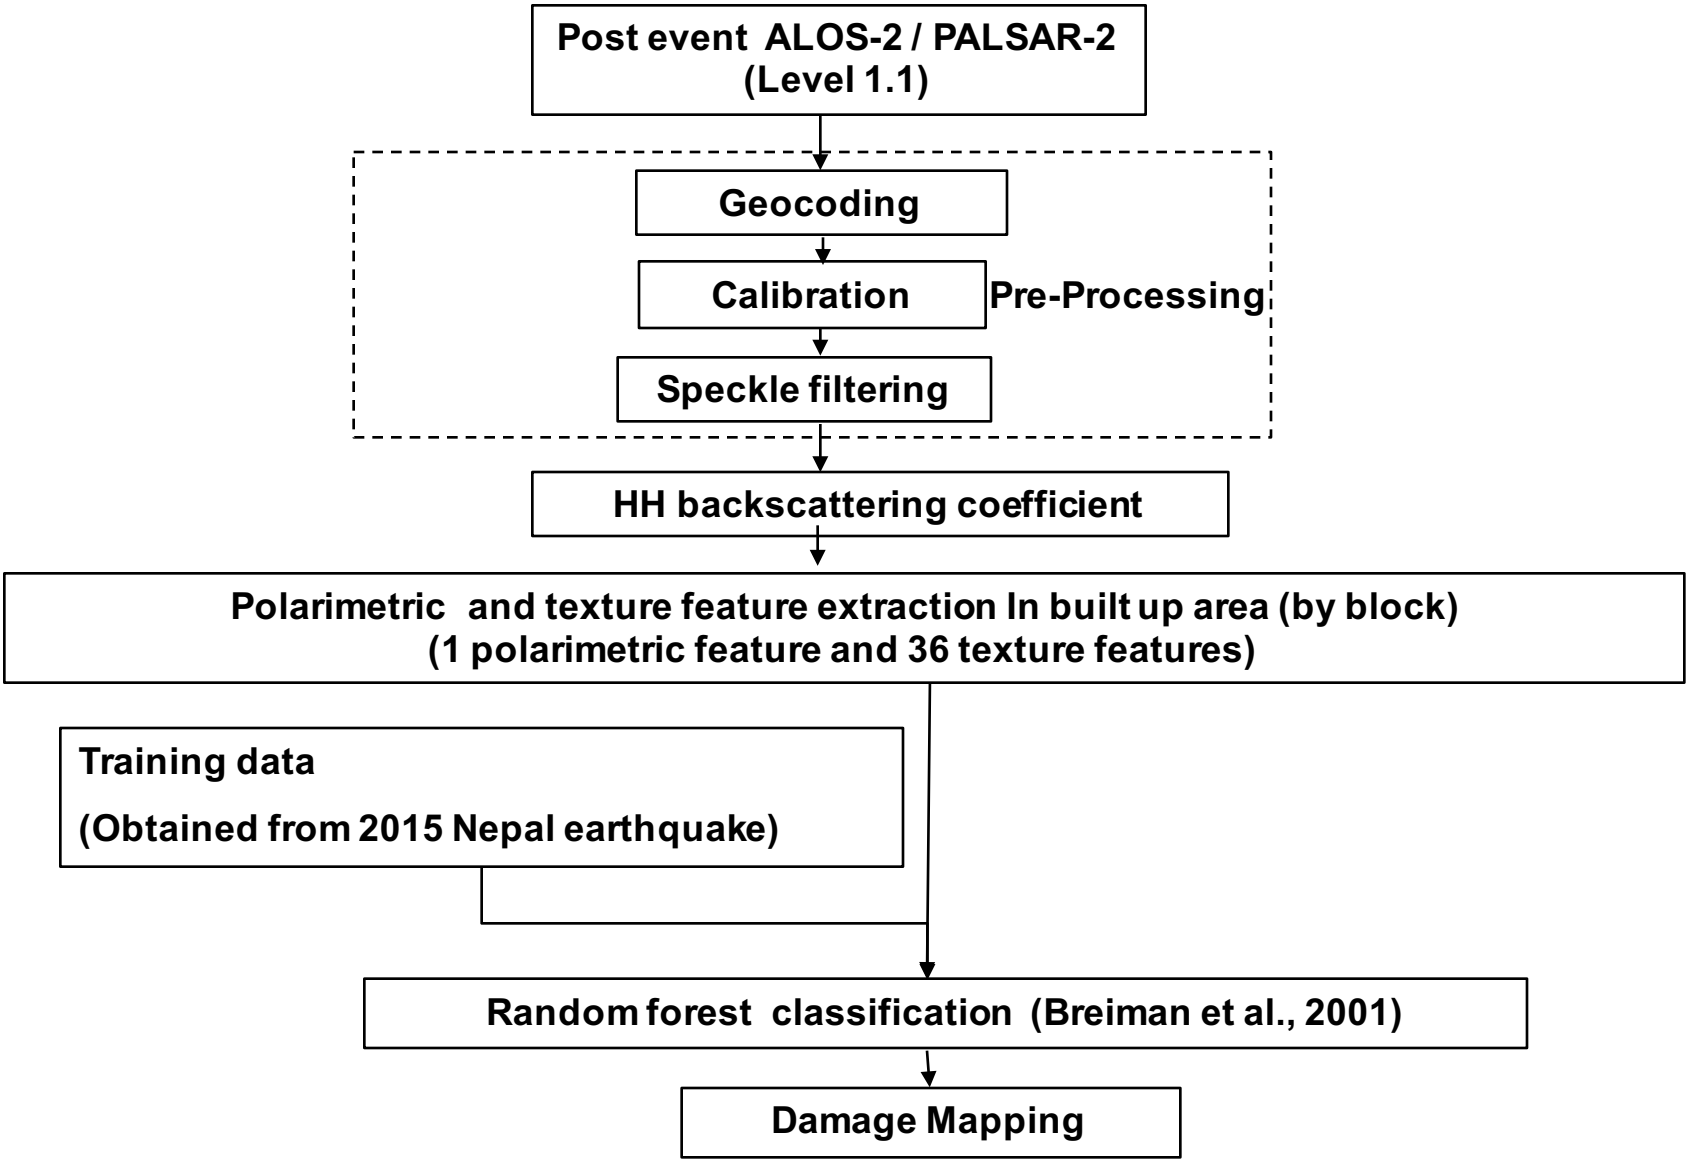
Method (Bai et al., 2015)

1. We calculated 37 texture parameters based on the Grey-Level Co-occurrence Matrix (Haralick et al., 1973), and the HH-polarization information.
2. We conducted the damage estimation in block-scale of 50 m x 50 m, the average value of each texture parameter is calculated in each block.
3. Finally, using training sample of structural damage observed in the 2015 Nepal earthquake, a random forest algorithm (Breiman et al., 2001) was applied to classify the building damage into two categories in Kumamoto city.
